BUILDING 1

CONDITION SURVEY

GENERAL'S QUARTERS

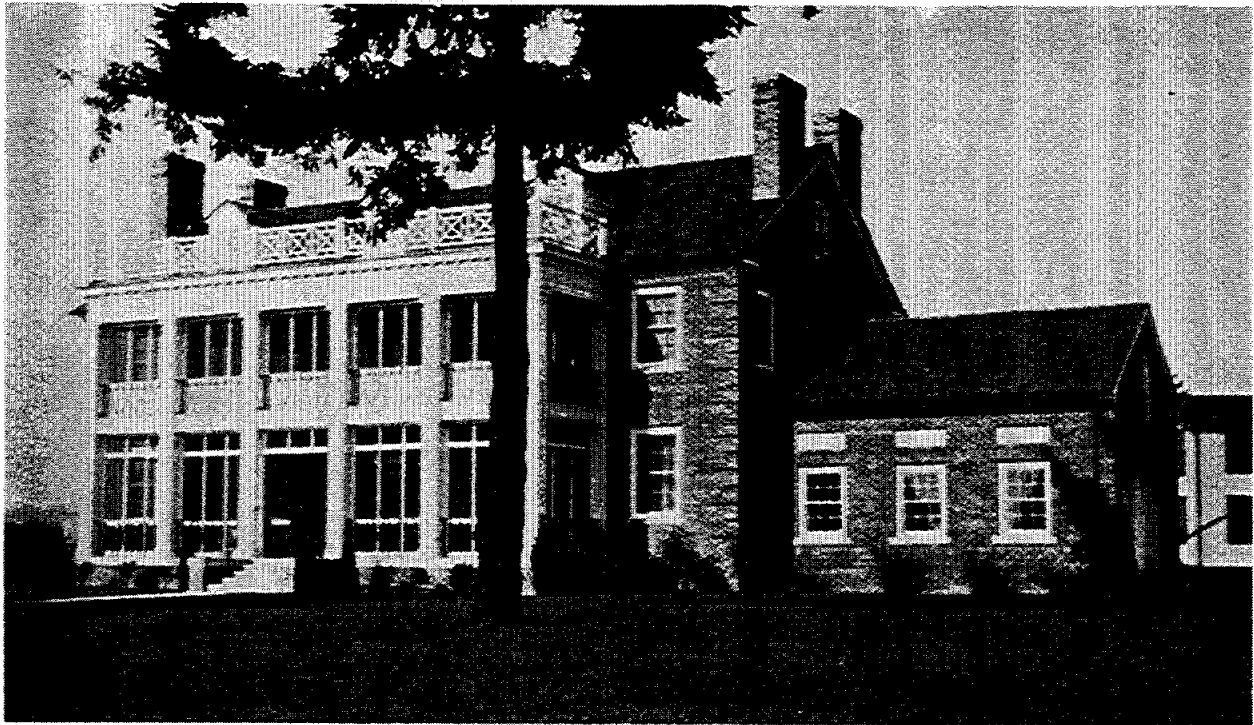
Building 1 (formerly 53) was completed in 1934 for Field Officer Quarters. It now serves as the general's quarters and is the largest 1-family residence on base. It is a two-story brick structure with a gable shingle tile roof. Foundation and first floor are reinforced concrete.

The building stands largely unaltered except for the front enclosed porch. The infill sections between columns have been changed with new window assemblies at both the first and second floor levels, the roof balustrade has been removed, and the entry steps have been extended also adding a columned flat canopy above.

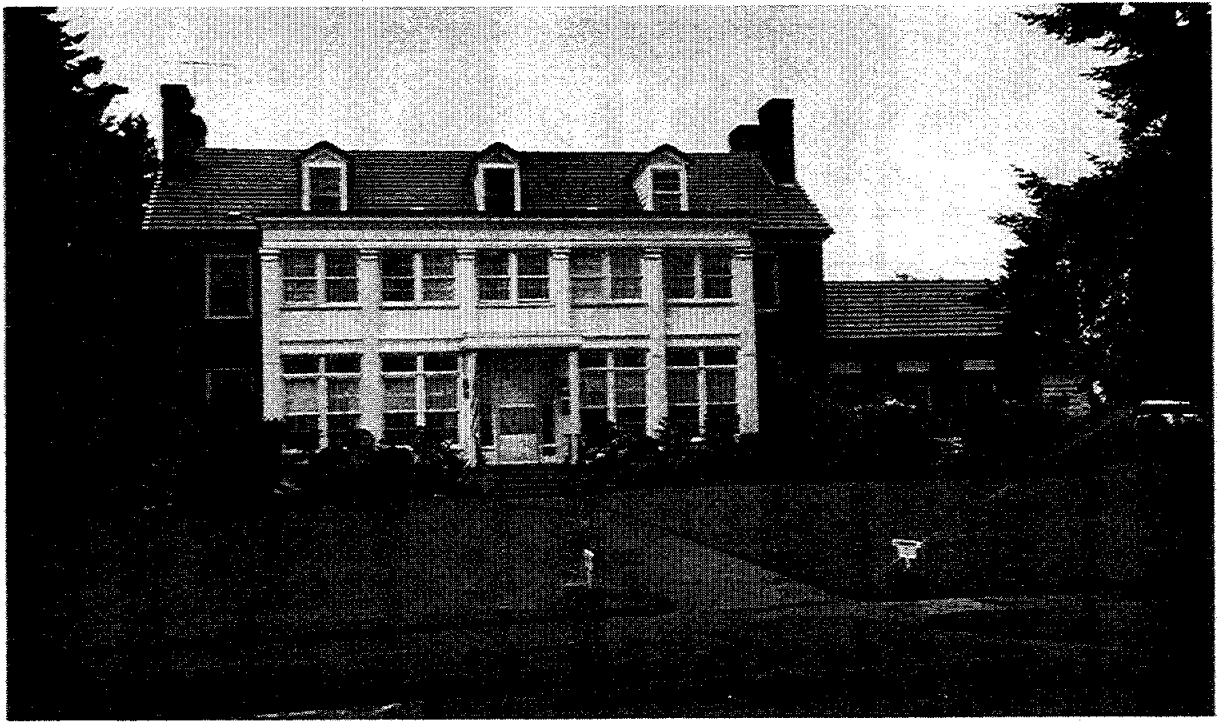
1987 PHOTO

1. Lower 3 feet of walls are heavily soiled and support moss growth.
2. Minor repointing is needed on the west (rear) wall.
3. Windows: Some missing putty. Peeling/chipped paint and heavily weathered (particularly at sills). Rusting nails in casings.
4. Rear entry roof balustrade: Severe peeling paint. Heavy paint build-up.
5. Dormers: deterioration and possible rot of siding and trim.
6. Check suitability of flashing at dormer side walls.
7. Soil piled up against wood at garage extension.
8. Enclosed front porch: Peeling paint on flashings, panels, trim. Moss growth on stone sill.
9. Columns: Water damage at base and cap. Moisture is getting into shaft.

1. MASONRY CLEANING

- a. Remove moss and clean walls according to recommended procedures in article on "Brick Masonry Walls".

2. REPOINTING

- a. Refer to article on "Brick Masonry Walls" and repoint accordingly.
- b. New mortar should be tinted to match existing mortar.
- c. Tool joints to match existing.

3. WINDOWS

- a. Recondition windows according to articles on "Wood Windows" and "Paint" and related illustrations.
- b. Remove rusting nails in casings. Fill holes.

4. ROOF BALUSTRADE

- a. Refer to articles on "Wood" and "Paint".
- b. Strip balustrade and associated trim of all paint layers.
- c. Resecure any loose or open joints.
- d. Repaint with one prime and two finish coats.
- e. Reconstruct balustrade on front porch roof using historic photos as guide.

8. FRONT PORCH

- a. Refer to articles on "Wood", "Paint", and "Masonry".
- b. Remove moss from stone sill and clean sill.
- c. Scrape and sand all wood panels and trim.
- d. Wire brush flashings.
- e. Repaint with one prime and two finish coats.

9. COLUMNS

- a. Refer to article on "Wood Columns".
- b. Flash top of column with lead sheet.
